ACCIDENT

Aircraft Type and Registration:	Alauda Airspeeder Mk II, (UAS, registration n/a)	
No & Type of Engines:	4 brushless DC electric motors	
Year of Manufacture:	2019	
Date & Time (UTC):	4 July 2019 at 1140 hrs	
Location:	Goodwood Aerodrome, West Sussex	
Type of Flight:	Demonstration flight	
Persons on Board:	Crew - None	Passengers - None
Injuries:	Crew - N/A	Passengers - N/A
Nature of Damage:	Destroyed	
Commander's Licence:	Remote Pilot Licence ¹	
Commander's Age:	22 years	
Commander's Flying Experience:	20 hours (of which 18 were on type) Last 90 days - 3 hours Last 28 days - 1 hour	
Information Source:	AAIB Field Investigation

Synopsis

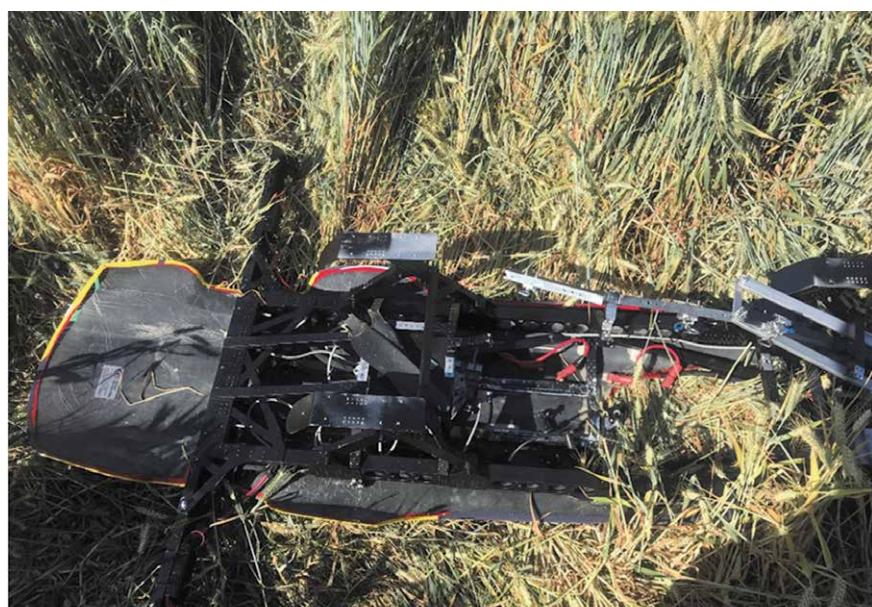
The UA came to rest inverted in a field of wheat, 875 m south-south-west of the takeoff point. The crop was dry and there was no post-impact fire. The accident site was 40 m from the nearest building which was in a group of houses on the north-eastern edge of Chichester, (Figure 4).

Figure 5
UA as found (inverted) at the accident site

The airframe had suffered permanent distortion and cracking from the impact, but no preaccident anomalies were found.

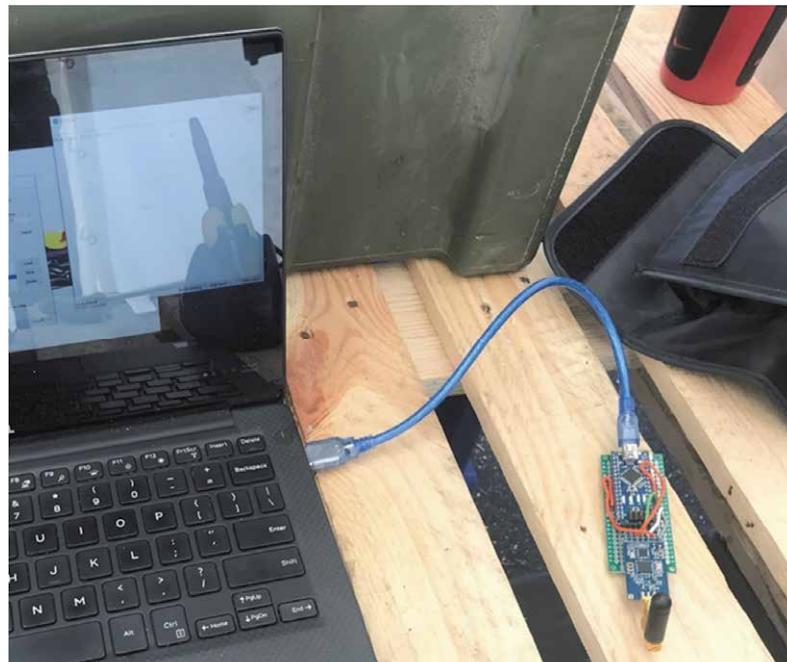
The ground-based part of the kill switch was a transmitter connected to a laptop via a trailing USB cable. All of the transmitter's electronics were exposed with no protective enclosure and, when used, the antenna and electronics hung underneath the laptop on the USB cable (Figure 8).

Figure 8
Ground-based kill switch

To activate the kill switch, a spotter was required to enter a command into a terminal on the laptop which communicated this to the USB transmitter. There was no two-way communication in the kill switch system. This meant that if connectivity was lost, it would remain unknown until an attempt was made to use the system.

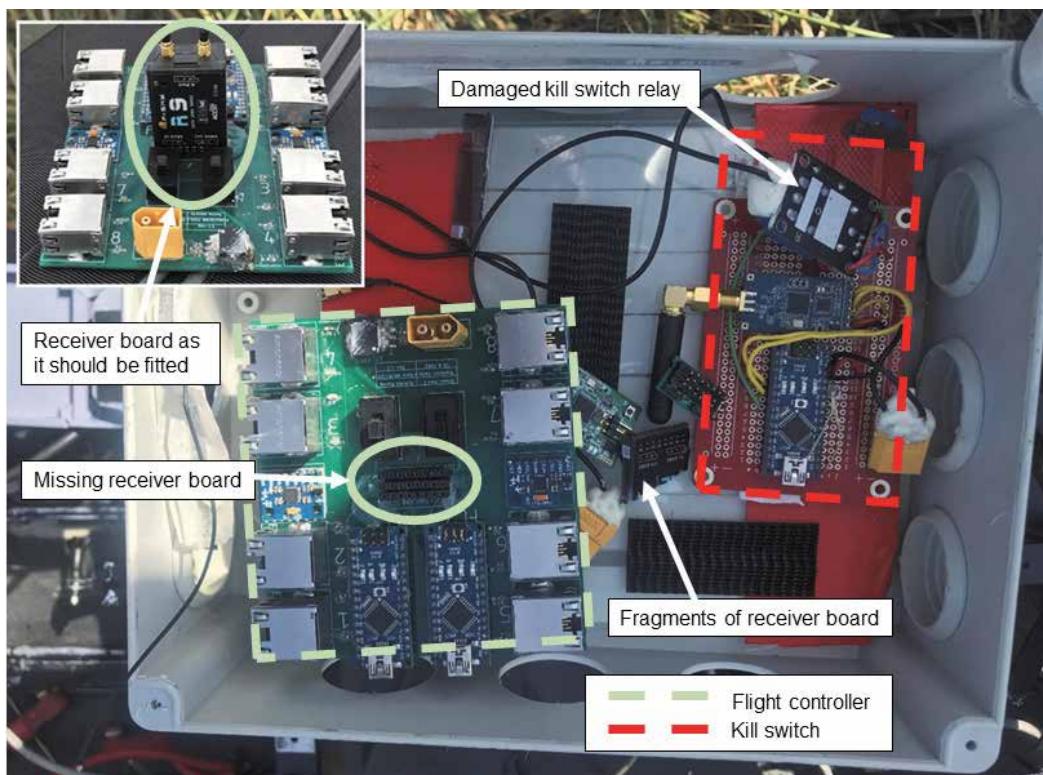
The flight control circuit board was present, but the operator had disconnected the ESC connection wires prior to AAIB arrival. The radio receiver, which was normally slotted into the circuit board, had detached and broken into several pieces (Figure 9). This damage was likely caused in the impact. Failure or loss of this component would lead to loss of link between the UA and pilot.

Initial examination of the on-board kill switch circuit board showed that the relay and one of the battery power supply leads had detached from the board. Loss of either of these components would render the kill switch inoperative. The antenna and the rest of the components all appeared to be in place.

Figure 9
Flight controls box at accident site

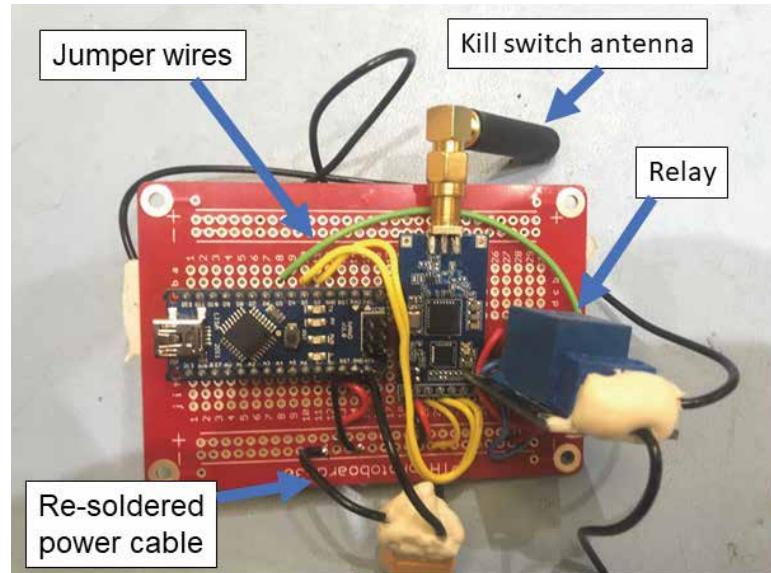
Initial examination of the circuit boards revealed some concerns regarding build quality and workmanship. The boards were populated with 'hobbyist' components with exposed wiring, large amounts of solder and lumps of adhesive. The kill switch used an electronics prototyping board with a number of jumper wires instead of a printed circuit. Failure of any of these wires would render the kill switch inoperative (Figure 10).

Figure 10
Kill switch on-board circuit board

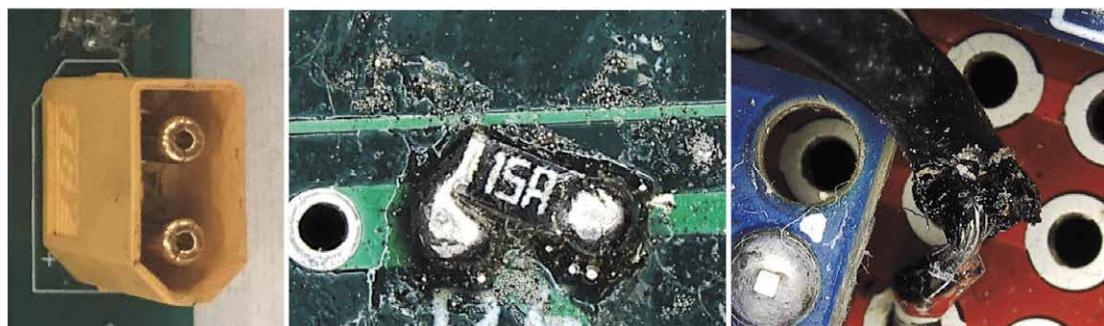
The examination revealed a number of issues with the flight control system and both the airborne and ground-based kill switch assemblies. All the assemblies failed an evaluation against all IPC A-610 classes due to quality and workmanship issues. Examples included misaligned components, burnt insulation, the use of solder bridges, excessive flux residues and a power connector that appeared to be installed in the incorrect orientation when compared to the drawn orientation on the circuit board (Figure 11).

Figure 11
Power connector installation, solder bridge and evidence of burnt insulation

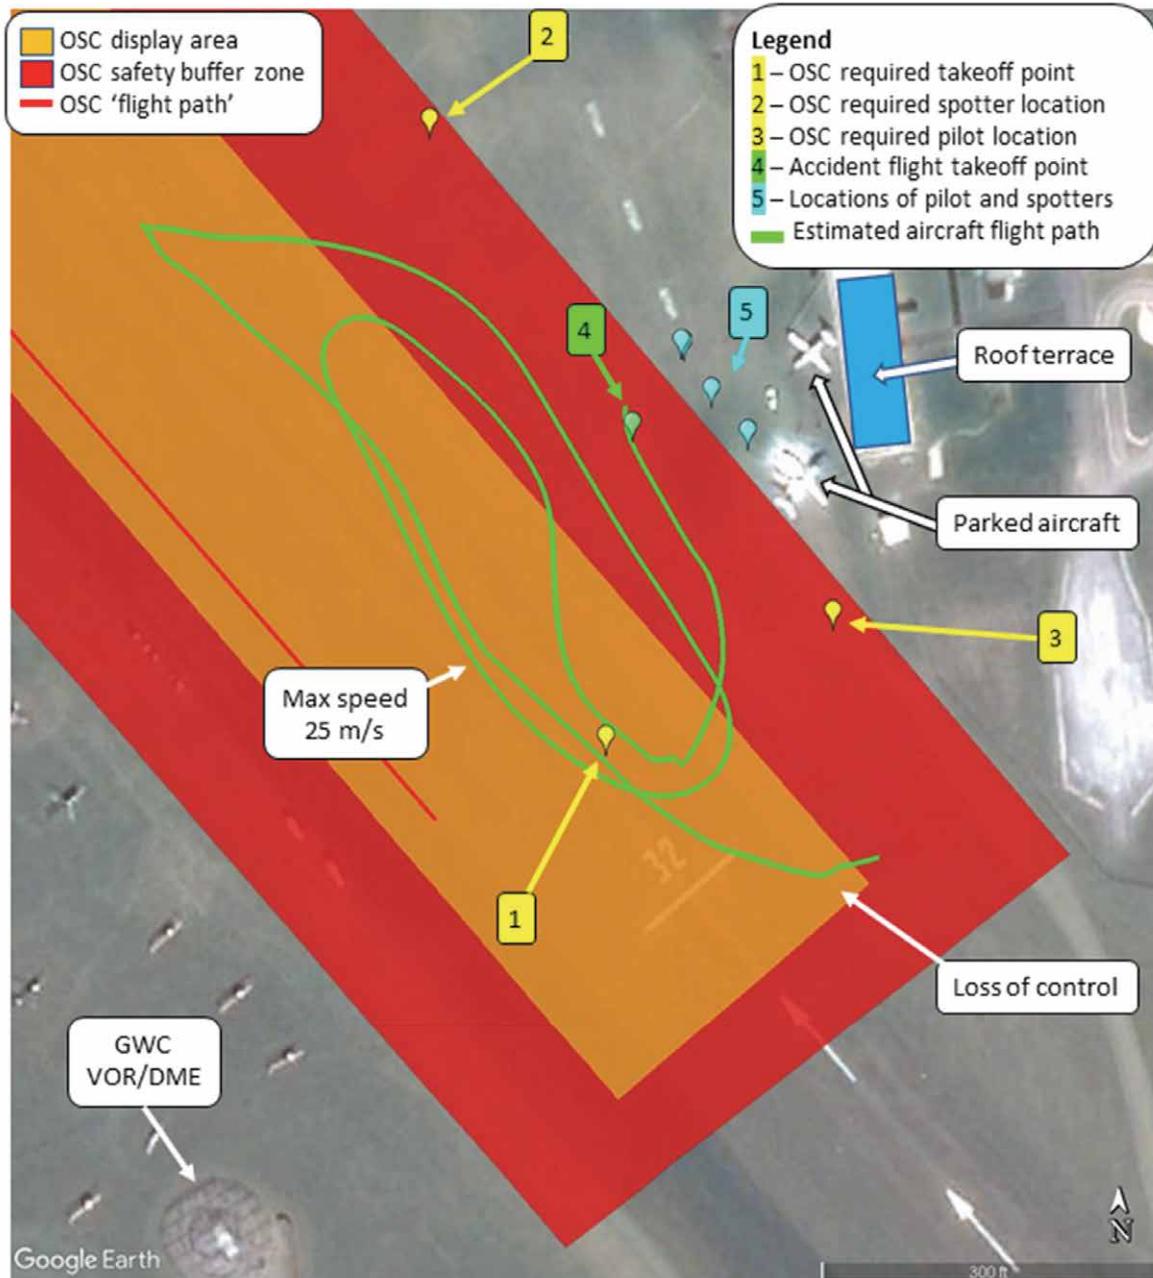
Figure 16 shows the takeoff location detailed in the OSC and the takeoff location ascertained from the video analysis. The aerial imagery is from a satellite image taken on the day of the accident. The aircraft took off 60 m from the aerodrome building and approximately 85 m from the designated takeoff / landing area.

Overhead view of Goodwood Aerodrome showing estimated aircraft flight path, location of personnel and their required locations.

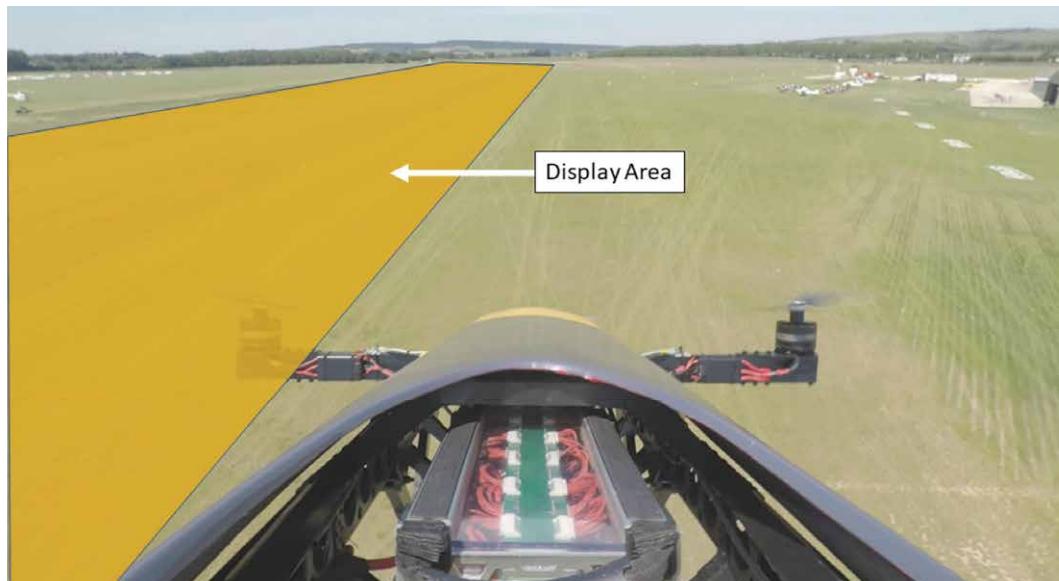
Aircraft on first pass to the east of Runway 32 inside the safety buffer zone

The calculated altitude during the display was within the CAA's exemption limit of 67 ft (20 m) but the groundspeed was in excess of 11 m/s on a number of occasions. The average groundspeed for the display was 12.9 m/s with a maximum of 25 m/s (Figure 19). With the aircraft at 20 m height and 25 m/s, using the CAA's calculations, the aircraft would travel 50 m if the kill switch was activated or power was lost.

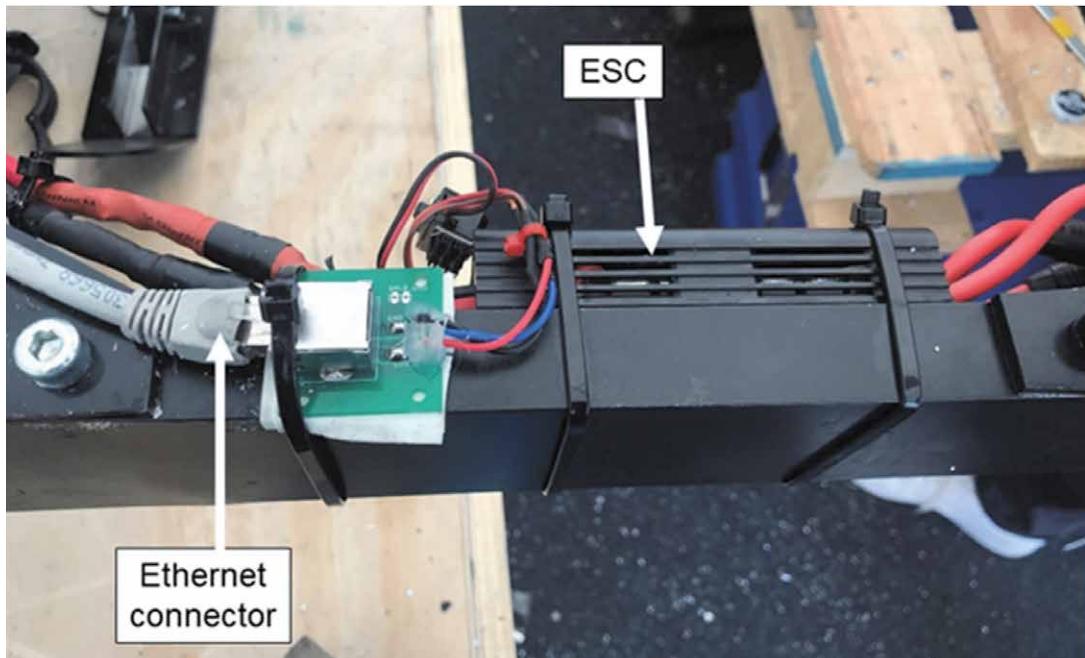
The construction of the aircraft used a large number of plastic tie-wraps to keep components in place. This included the ESCs, cabling and the connector plates from the control system ethernet cables to the ESCs (Figure 22). Failure of any of these connectors or cables would render the aircraft uncontrollable.

Figure 22
Ethernet cable, connector plate and ESC
