ACCIDENT

Aircraft Type and Registration:	Alauda Airspeeder Mk II, (UAS, registration n/a)	
No & Type of Engines:	4 brushless DC electric motors	
Year of Manufacture:	2019	
Date & Time (UTC):	4 July 2019 at 1140 hrs	
Location:	Goodwood Aerodrome, West Sussex	
Type of Flight:	Demonstration flight	
Persons on Board:	Crew - None	Passengers - None
Injuries:	Crew - N/A	Passengers - N/A
Nature of Damage:	Destroyed	
Commander's Licence:	Remote Pilot Licence ¹	
Commander's Age:	22 years	
Commander's Flying Experience:	20 hours (of which 18 were on type) Last 90 days - 3 hours Last 28 days - 1 hour	
Information Source:	AAIB Field Investigation

Synopsis

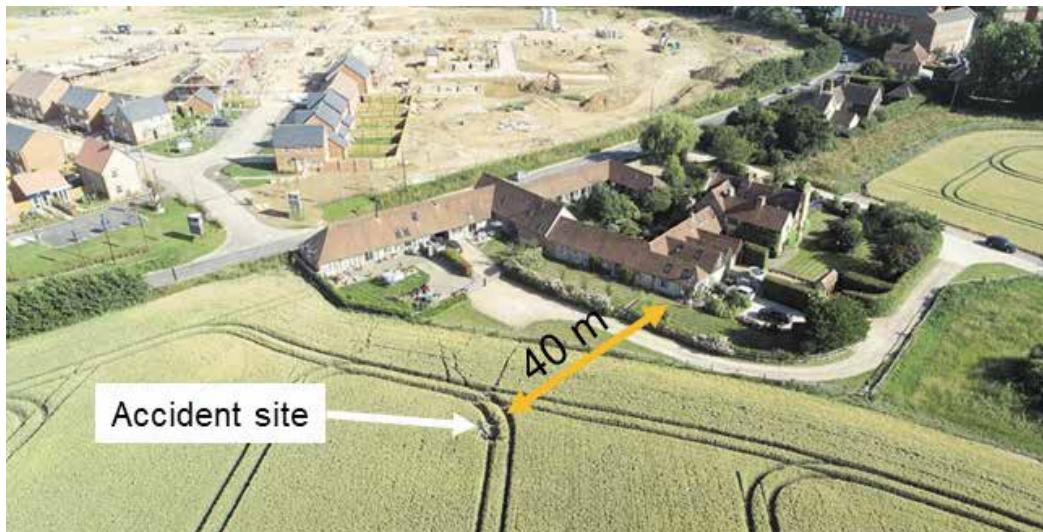
Figure 4
Accident site, looking south

The UA came to rest inverted in a field of wheat, 875 m south-south-west of the takeoff point. The crop was dry and there was no post-impact fire. The accident site was 40 m from the nearest building which was in a group of houses on the north-eastern edge of Chichester, (Figure 4).

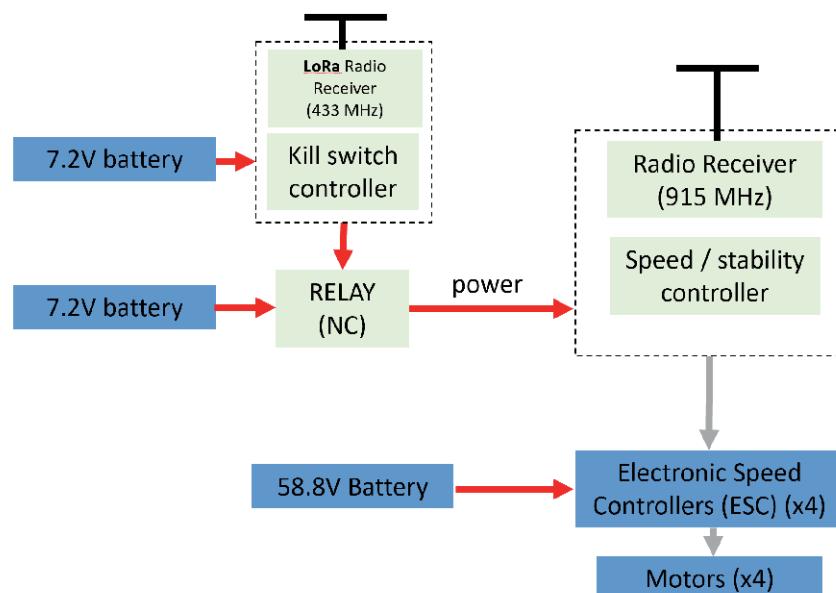
Figure 7
On-board control system schematic

The flight controller power supply was routed through a relay, which was controlled by a kill switch. This relay was wired in the 'Normally Closed (NC)' position meaning that if the kill switch was unpowered, power was still available to the flight controller (Figure 7). When activated, the kill switch opened the relay, cutting the power to the flight controller. With the control system unpowered, the ESCs would receive no command and the motors would stop.

The kill switch was powered by an independent 7.2 V battery and operated on a different frequency (433 MHz LoRa⁹) and control system to the normal flight control system. This system was also used to allow the UA to be safely electrically isolated during manual handling on the ground.

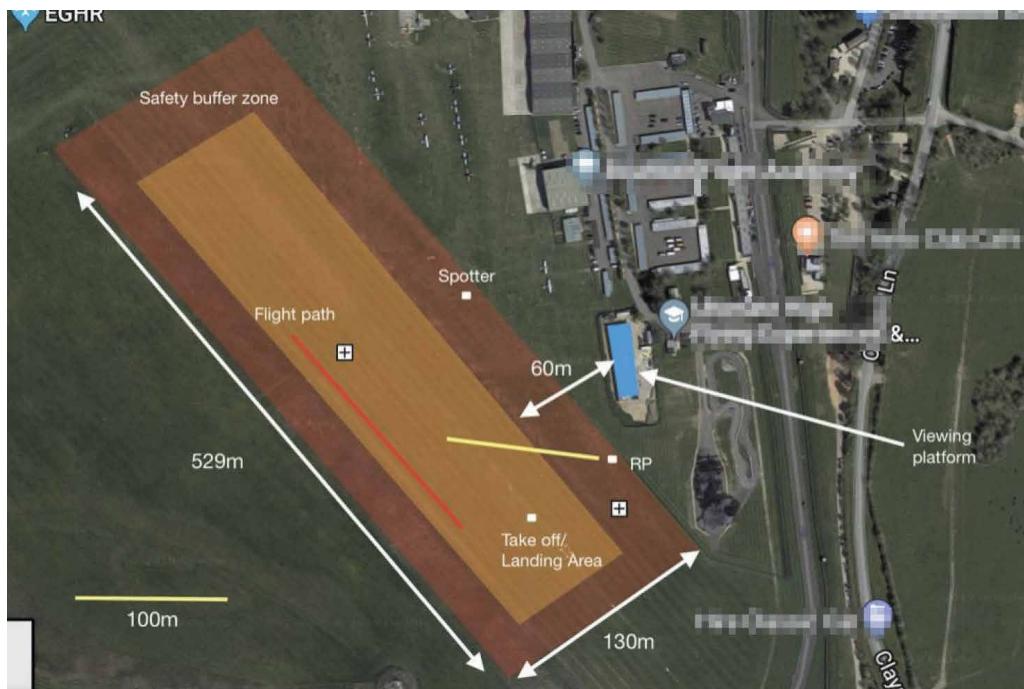
Invited guests were to be located on the viewing platform. The area in orange in Figure 13 is the flight area where the operator was to perform the display. The area shaded red is the safety buffer zone which the OSC stated that if flown in '*will require a response from spotter to alert the RP [Remote Pilot] of the perimeter breach and initiate redirection procedures*'.

Operating area detail from Flight Approval Form in OSC Volume 1

The display area and safety buffer zone defined in the OSC were generated using the eastern edge of Runway 32 as the edge of the display area. This display area was drawn using a Google Earth image from 2015. In August 2017, the aerodrome modified Runway 14/32 by reducing its width from 45 m to 30 m by reducing the eastern edge by 15 m. This meant the display area defined in the OSC did not represent the correct runway geometry on the day of the accident. If the pilot was using the edge of Runway 14/32 as the edge of display area, the width would be 15 m less than that defined in the OSC. The AIP entry at the time of the application contained up to date information.

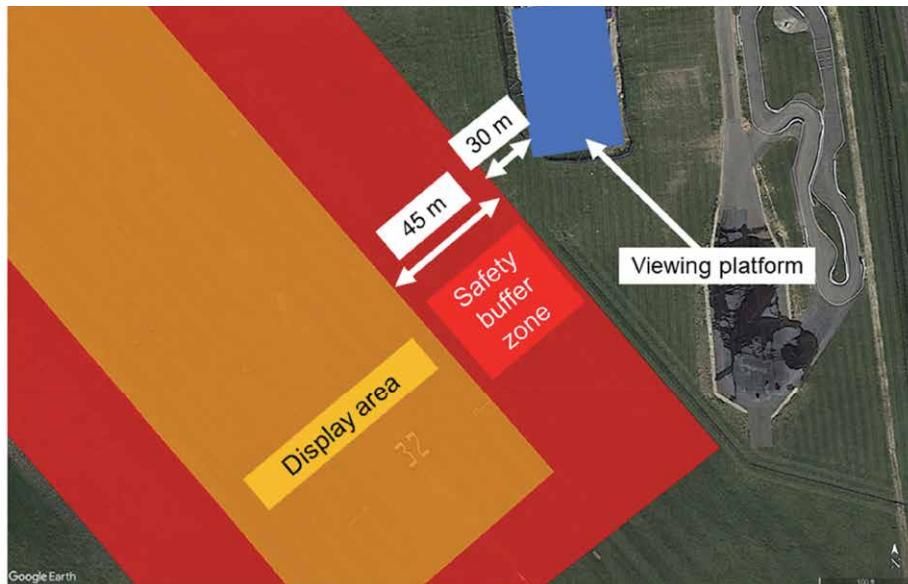
Figure 14

The display area dimensions (orange area in Figure 14) defined in the OSC were approximately 90 m x 450 m, with the safety buffer zone extending towards the viewing platform by 45 m. The viewing platform was 30 m from the edge of the red safety buffer zone (Figure 13).

Viewing platform distances from display area and safety buffer zone

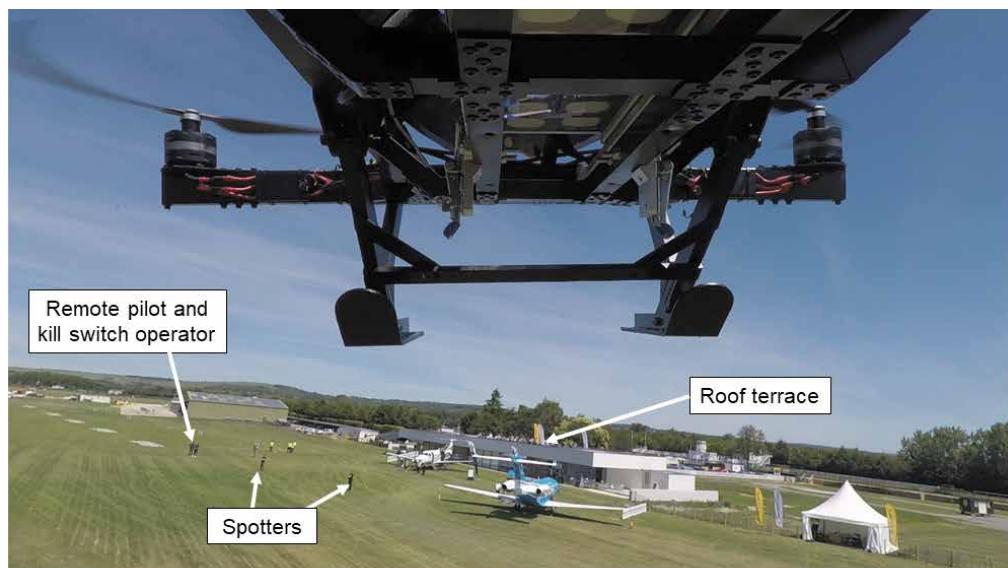
Figure 15

Video footage was reviewed to compare requirements of the CAA exemption and the operation of the aircraft. The review confirmed that, within the camera's field of view, the UA remained intact for the display with no visible failures of the motors, propellers, ESCs, airframe and battery. The footage also revealed a number of items including aircraft parked in front of the aerodrome building (Figure 15) and two fuel bowsers parked within the safety buffer zone. At times, during low-speed turns, the aircraft was pointed directly towards the aerodrome building.

View from bottom rearward-facing camera towards the aerodrome building, just after takeoff

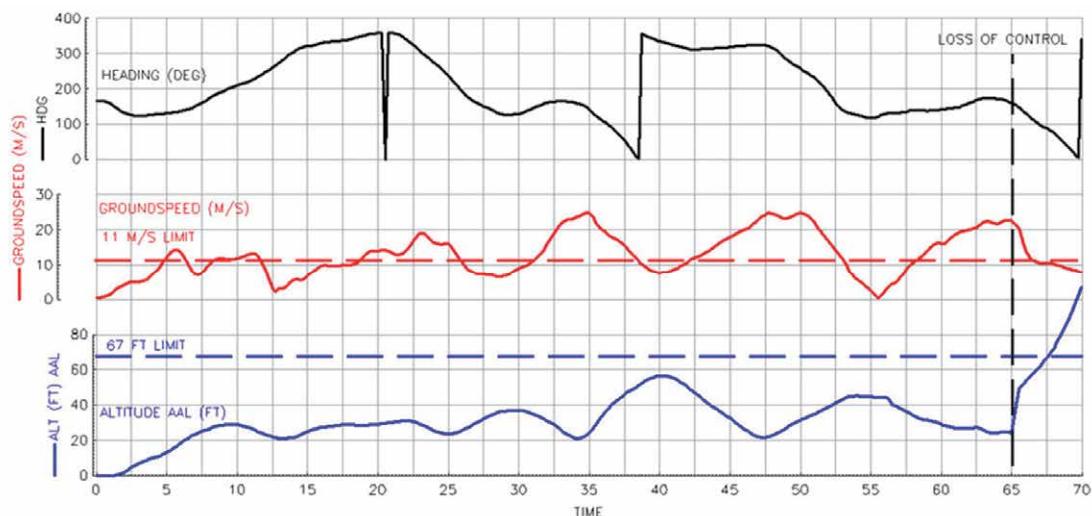
Figure 19

The calculated altitude during the display was within the CAA's exemption limit of 67 ft (20 m) but the groundspeed was in excess of 11 m/s on a number of occasions. The average groundspeed for the display was 12.9 m/s with a maximum of 25 m/s (Figure 19). With the aircraft at 20 m height and 25 m/s, using the CAA's calculations, the aircraft would travel 50 m if the kill switch was activated or power was lost.

Derived heading, groundspeed and altitude from video analysis

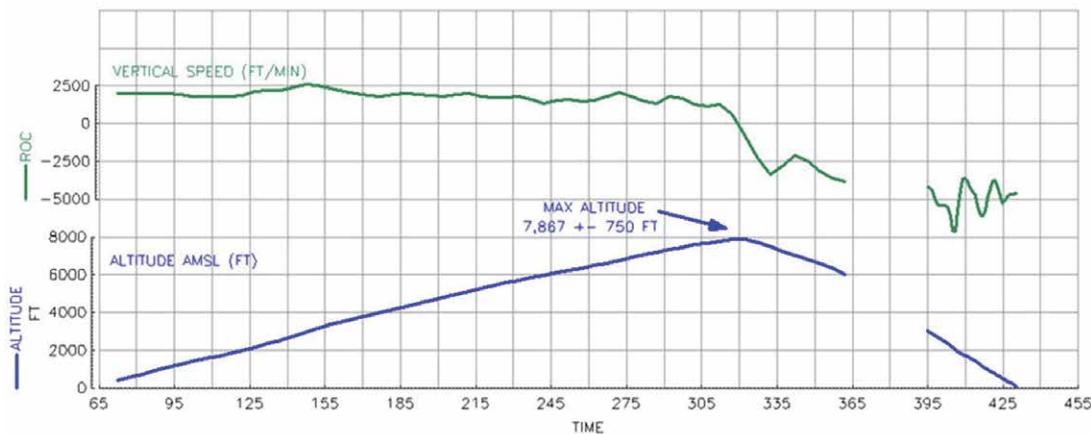
Figure 20

As per design, the aircraft continued at its previous throttle setting and with the self-levelling function, began a climb with a yaw rate of approximately $40^\circ/\text{sec}$. The aircraft climbed, uncontrolled, for 4 minutes 12 seconds, initially at around 2,000 ft/min. The rate reduced towards the top of the climb as the battery became depleted (Figure 20). The accuracy of the altitude estimation decreased as the altitude increased so a precise maximum altitude could not be established. The video analyst estimated this as 7,867 ft with an estimated error margin of ± 750 ft (see also below).

Altitude and vertical speed profiles.
Note gap in the data is where analysis was not performed.

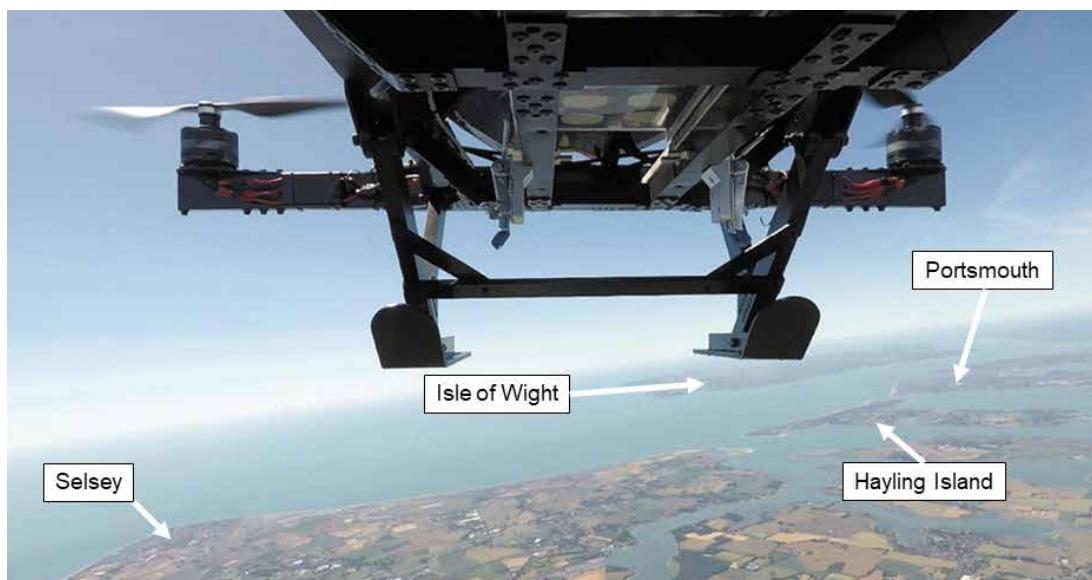
Figure 21
View at apogee from onboard camera

At the top of climb, the bottom camera captured the view over the south coast of West Sussex and Hampshire with the southern coast of the Isle of Wight visible (Figure 21).
